# Manhole Inspection Summary

Manhole # S35WW\_018MH

**Location** Address: **3100 BARCLAY ST**

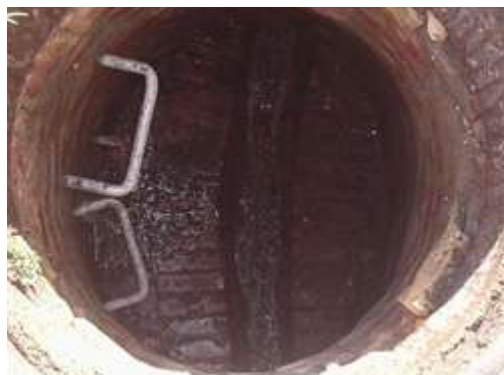
Top View

Corroded steps. Evidence of surcharge - Bench debris.

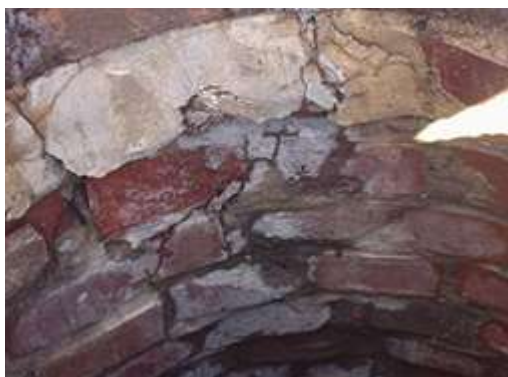
Defect

Frame leaks. Adjustment deterioration and infiltration. Corbel cracks and infiltration.

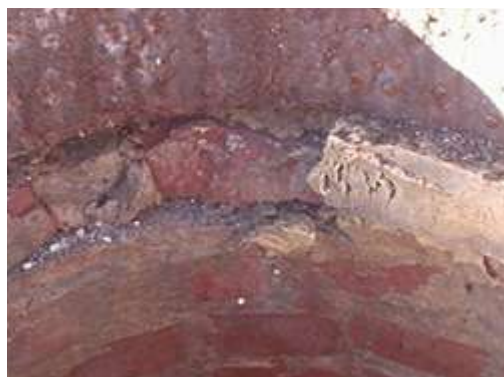
Defect

Frame leaks. Adjustment deterioration and infiltration - other side.

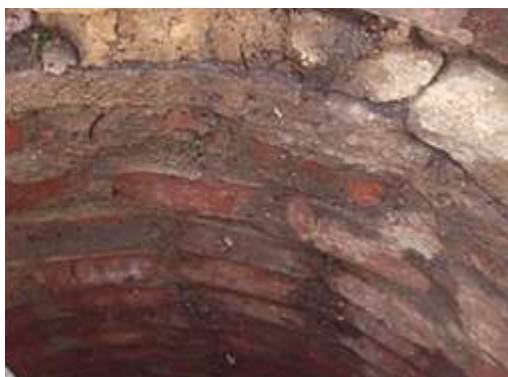
Defect

Frame leaks. Adjustment deterioration and infiltration.

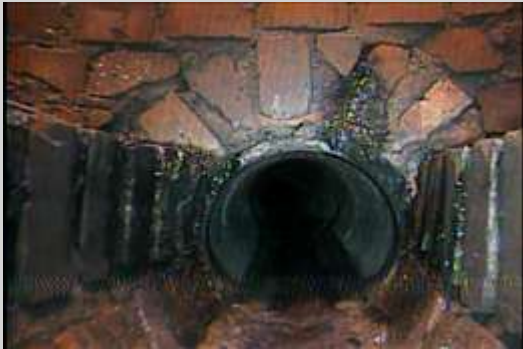
### 8 in. Circular Gravity Sewer Pipe Out @ 12 O'Clock

Channel deterioration.

Infiltration: **Dripper** Pipe Seal Cond: **Unknown**

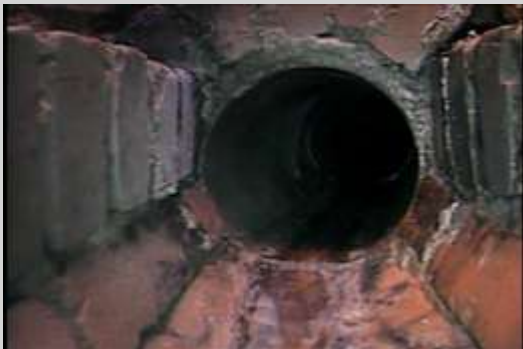
### 8 in. Circular Gravity Sewer Pipe In @ 6 O'Clock

Infiltration: **Evidence** Pipe Seal Cond: **Unknown**
